Reserve Study for

Highland Plantation Owners Association, Inc.

Macon, GA

January 9, 2025

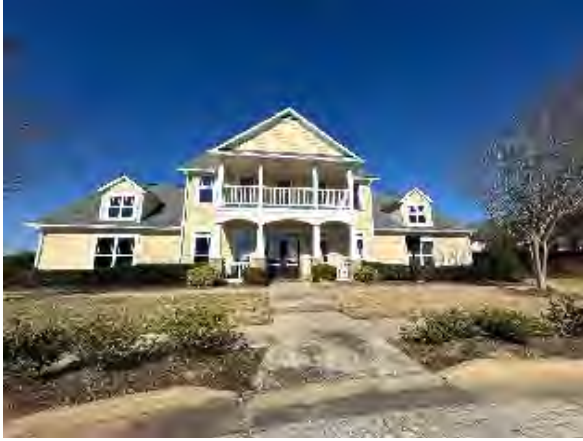
- The buildings are clad with cement board (Hardie board) siding and brick veneer. Cement board siding can reasonably be expected to last 50+ years depending on the geographical location of the property and the routine maintenance practices. Global Solution Partners has provided a cement board siding repair or replacement allowance - based on 20% of the total square footage - to provide funding for the general maintenance or necessary repairs to the cement board exterior surfaces throughout the study period.

Clubhouse Exterior

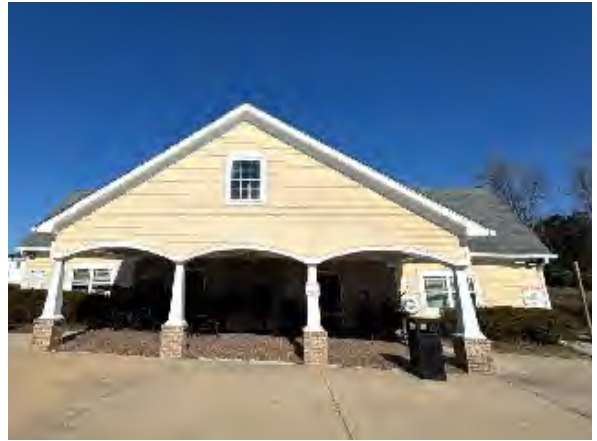
- Per information provided by the client, the poolhouse and clubhouse roofs were replaced in 2022. The life expectancy of the current roofing system is approximately 20 years when new. Various conditions may impact the actual life expectancy, therefore, it is recommended that periodic evaluations are performed by a qualified contractor and the Reserve Study is updated accordingly.

Pool House Exterior

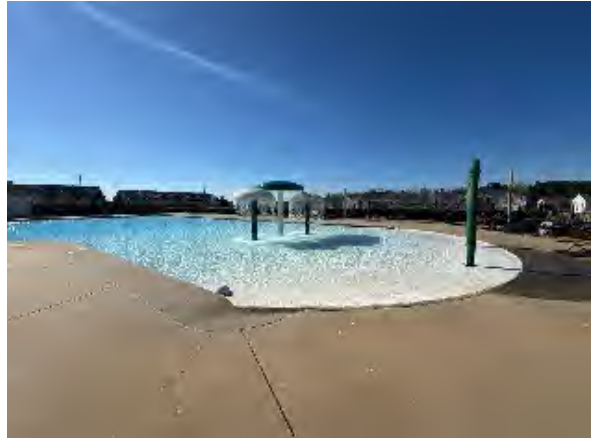
- Per information provided by the client, the pool was resurfaced in 2023 for \$84,000. No invoices were provided by the client.
- Per information provided by the client, the mushroom water feature and the water slide were installed in 2006. The life expectancy of the mushroom water feature and the water slide is 15 years when new. Various conditions may impact the actual life expectancy, therefore, it is recommended that periodic evaluations are performed by a qualified contractor and the Reserve Study is updated accordingly.

Pool and Mushroom Water Feature View

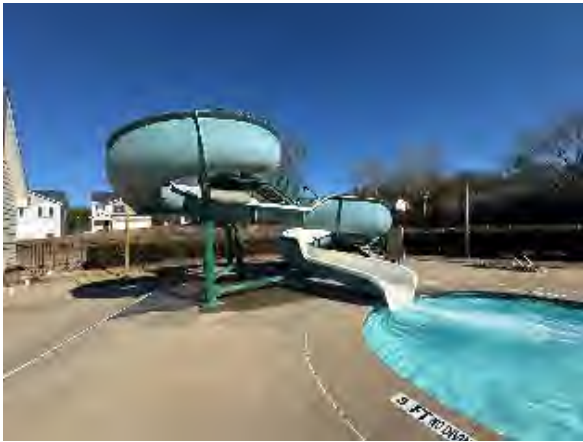
Water Slide at Pool

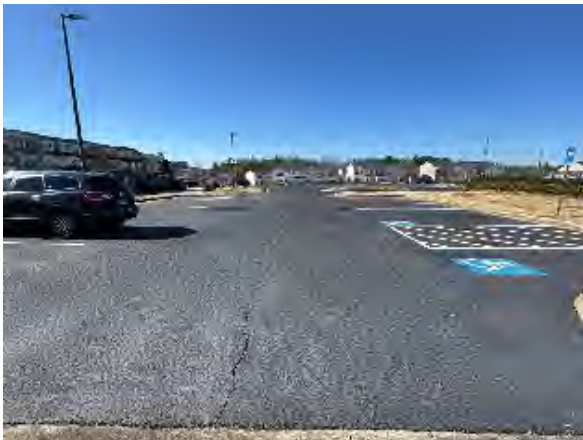
- The asphalt surfaces were observed to be in fair condition. Evidence of previous repairs was observed, the surface is worn, and cracking was noted throughout. Per information provided by the client, the parking area received a patch and seal in 2022 for \$6,000. Asphalt surfaces should be resealed on a five-year schedule to provide protection from oxidation due to exposure to the sun and elements, minimize surface cracking, and enhance the aesthetics of the community.

Parking Lot View

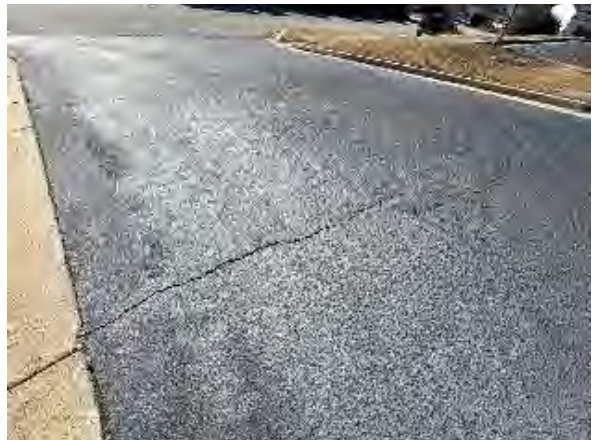
Parking Lot - Cracking
